MASTER PLAN FOR EASTERN CEMETERY, CITY OF PORTLAND, MAINE

**MASTER PLAN FOR
EASTERN CEMETERY
CITY OF PORTLAND, MAINE**

Prepared By: Michael
Trinkley, Ph.D. and
Debi Hacker

March 1, 2011

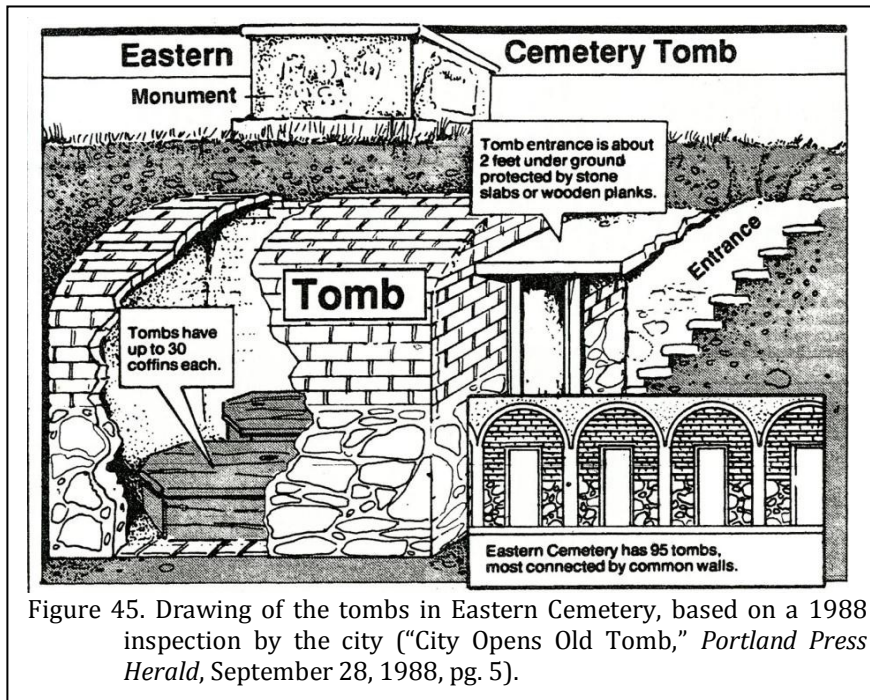
Figure 45. Drawing of the tombs in Eastern Cemetery, based on a 1988 inspection by the city ("City Opens Old Tomb," *Portland Press Herald*, September 28, 1988, pg. 5).

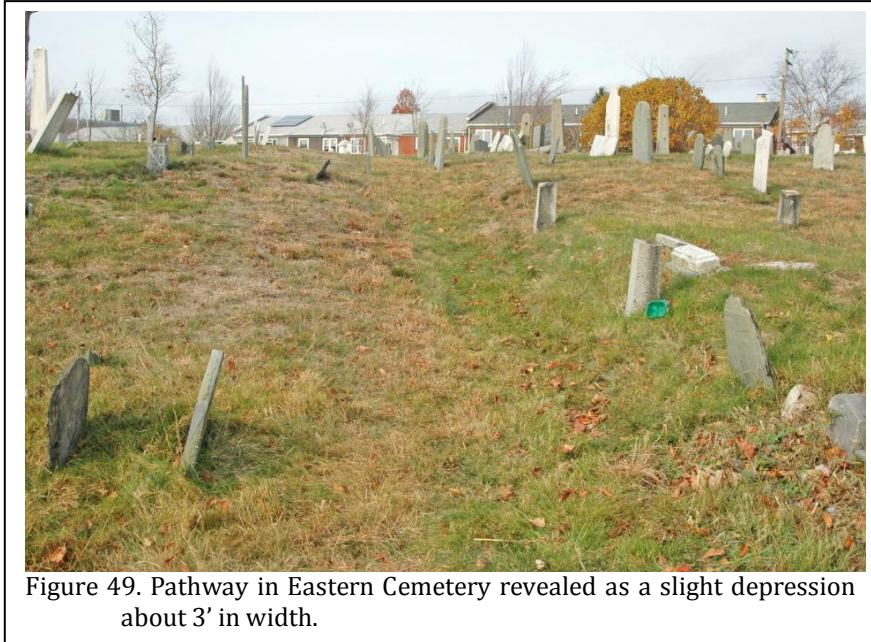
Figure 49. Pathway in Eastern Cemetery revealed as a slight depression about 3' in width.

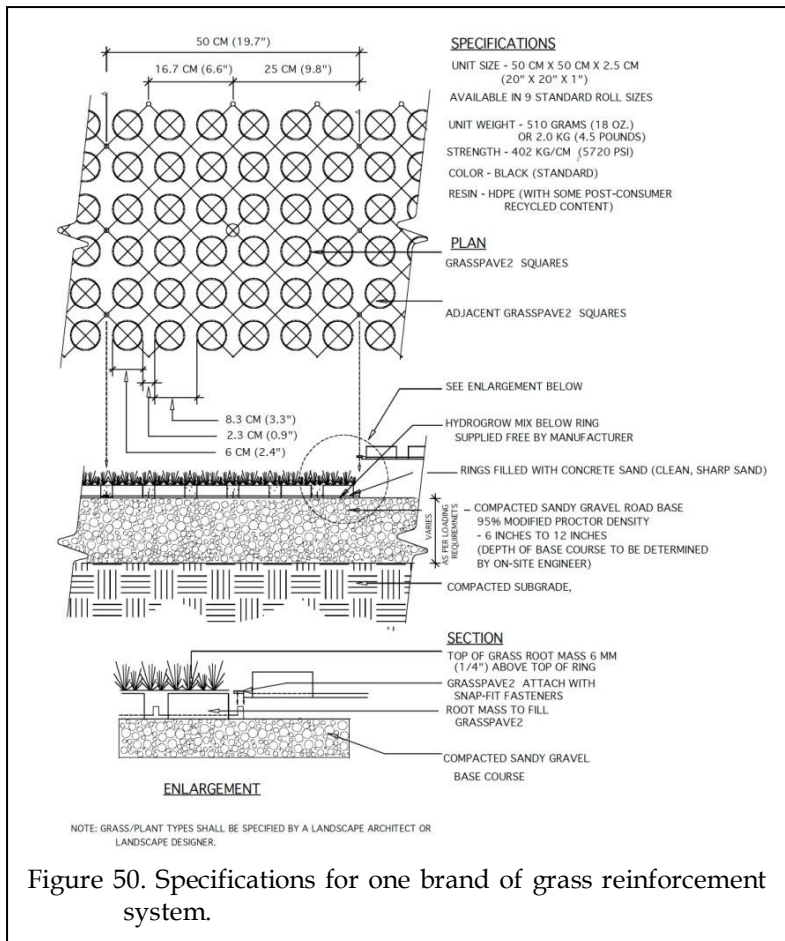
Figure 50. Specifications for one brand of grass reinforcement system.

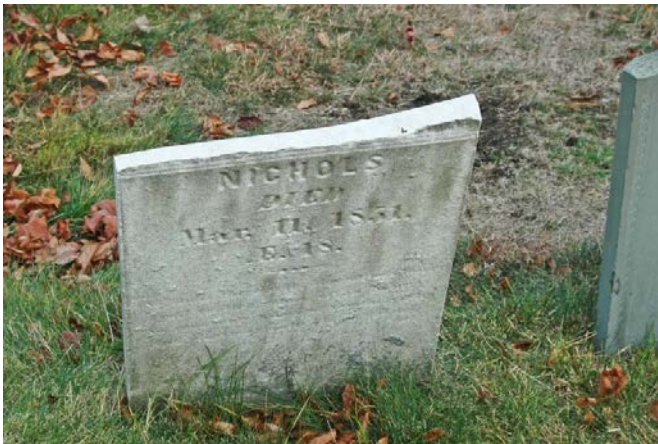
Figure 51. Probable recent vandalism, based on the unweathered and very white break.

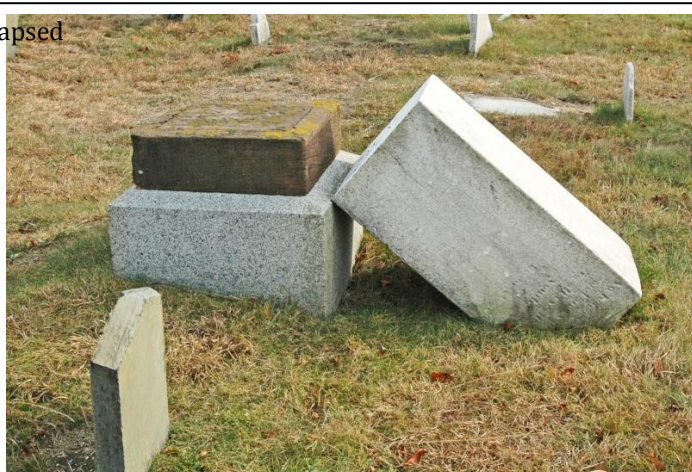
Figure 52. Previous damage that continues to affect the appearance of Eastern Cemetery.

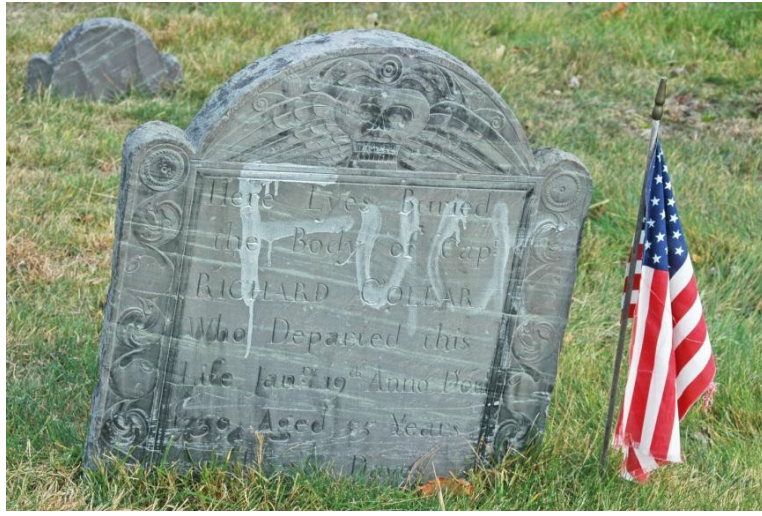
Figure 53. Example of graffiti in the cemetery. Graffiti should *always* be removed as soon as it is noticed.

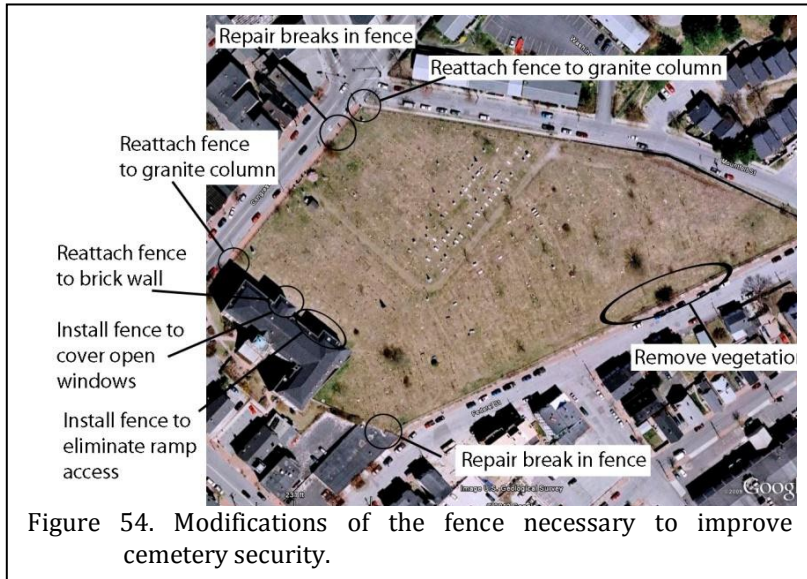
Figure 54. Modifications of the fence necessary to improve cemetery security.

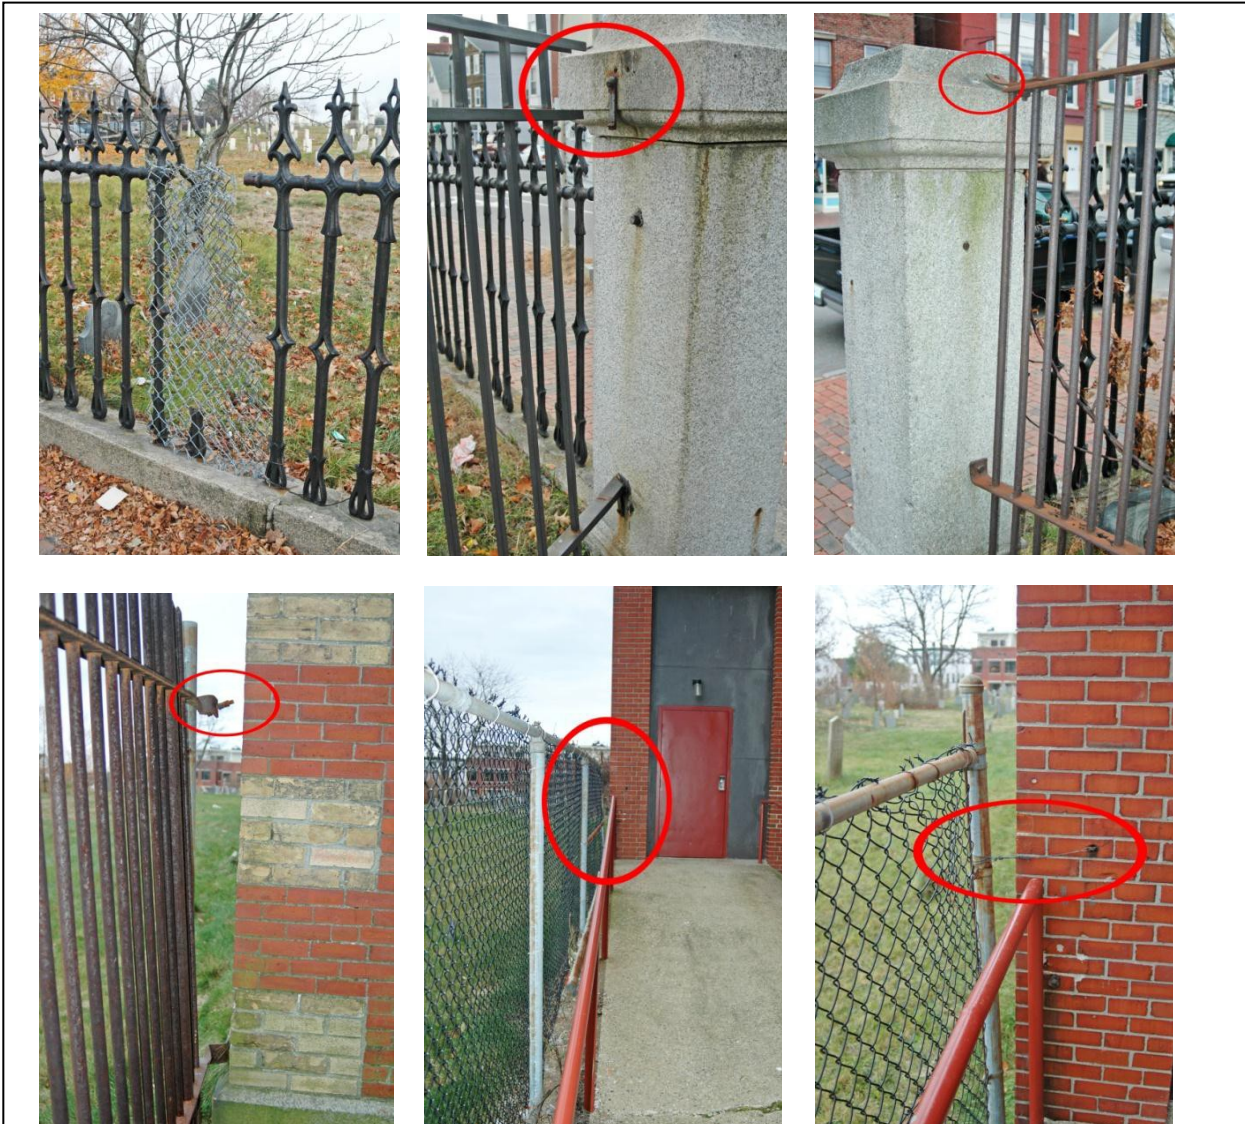
Figure 55. Fence problems that require immediate action. Upper left shows damaged section on Congress Street that allows ready access to the cemetery. Upper middle shows the damage to the connector at the corner of Congress and Mountfort streets. Upper right shows the damaged connector on Congress at the North School line. Lower left shows the damaged connector attaching the fence to North School. Lower middle shows that the fence along the North School ramp is not high enough to prevent entry. Lower right shows the damaged connector of the chain link fence to North School. Not shown is the damaged fence at the south edge of the cemetery along the rooftop of adjacent businesses.

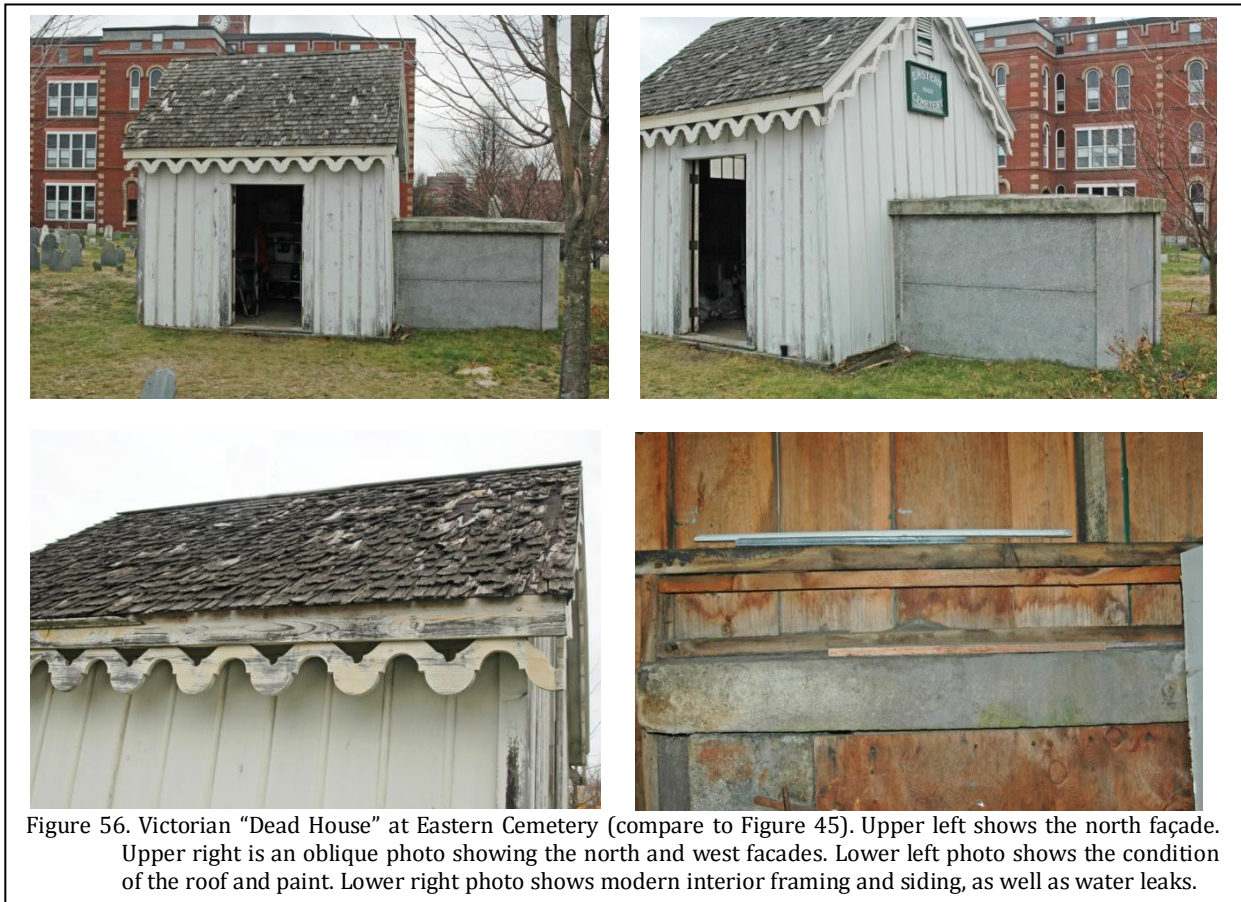
Figure 56. Victorian “Dead House” at Eastern Cemetery (compare to Figure 45). Upper left shows the north façade. Upper right is an oblique photo showing the north and west facades. Lower left photo shows the condition of the roof and paint. Lower right photo shows modern interior framing and siding, as well as water leaks.

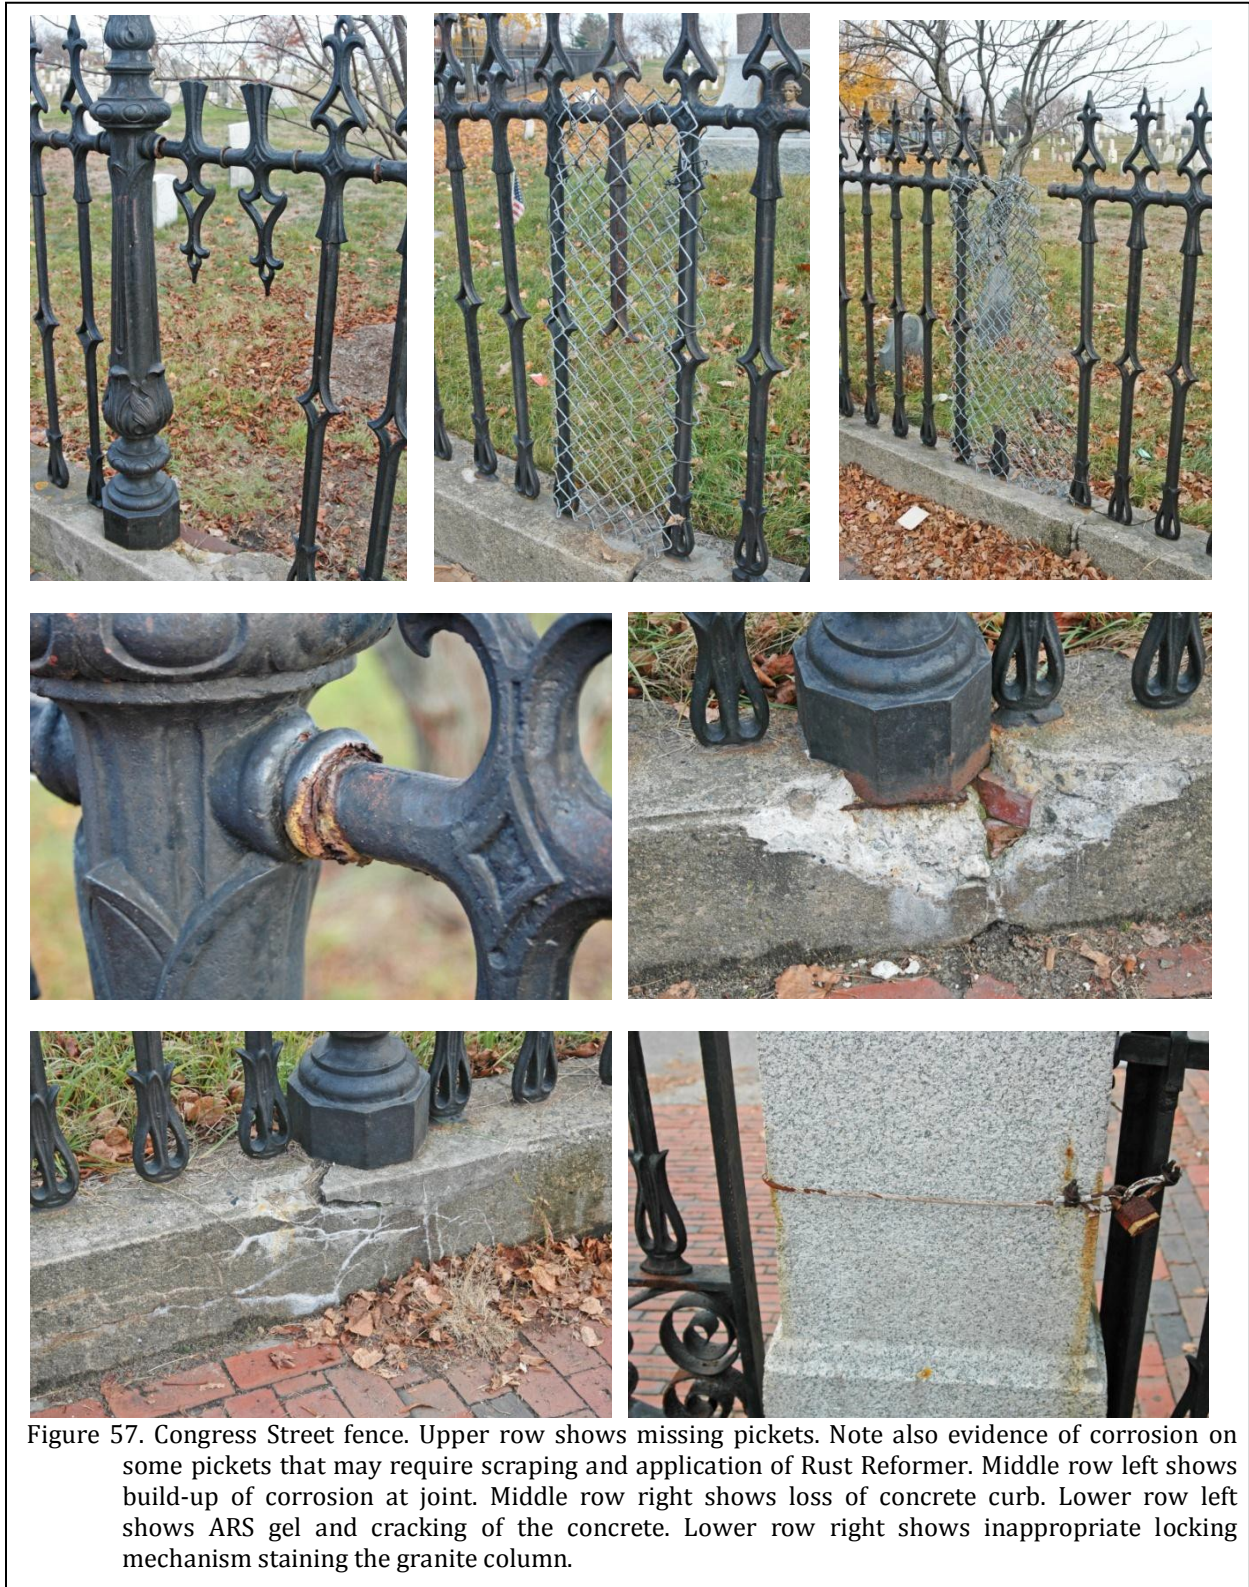
Figure 57. Congress Street fence. Upper row shows missing pickets. Note also evidence of corrosion on some pickets that may require scraping and application of Rust Reformer. Middle row left shows build-up of corrosion at joint. Middle row right shows loss of concrete curb. Lower row left shows ARS gel and cracking of the concrete. Lower row right shows inappropriate locking mechanism staining the granite column.

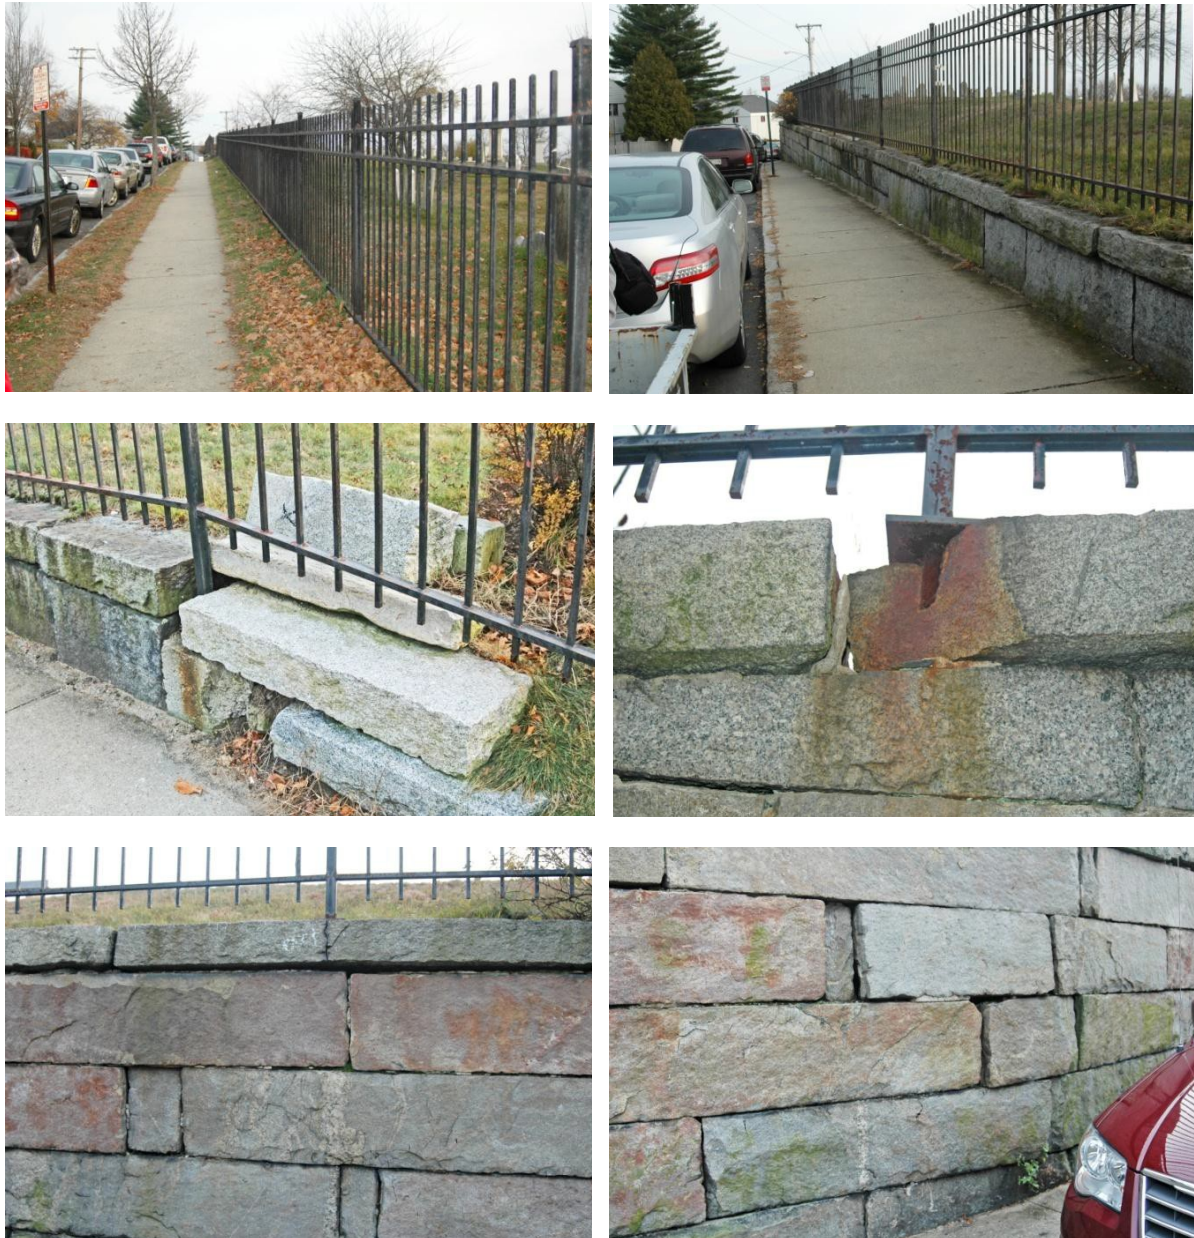
Figure 58. Mountfort Street fence and wall. Upper left photo shows the fence, looking to the northeast. Upper right shows the fence set on the granite retaining wall. Middle left shows where the granite wall has been “extended” by dumping granite coping. Middle right photo shows where iron jacking has split the granite coping. Lower left photo shows loss of mortar in the joints of the wall. Note also the crack that has formed from iron jacking at the line post in the center of the photo. Lower right shows a noticeable bulge in the wall on Mountfort. Joints are open and the retaining rock is set back in the wall, showing the movement outward.

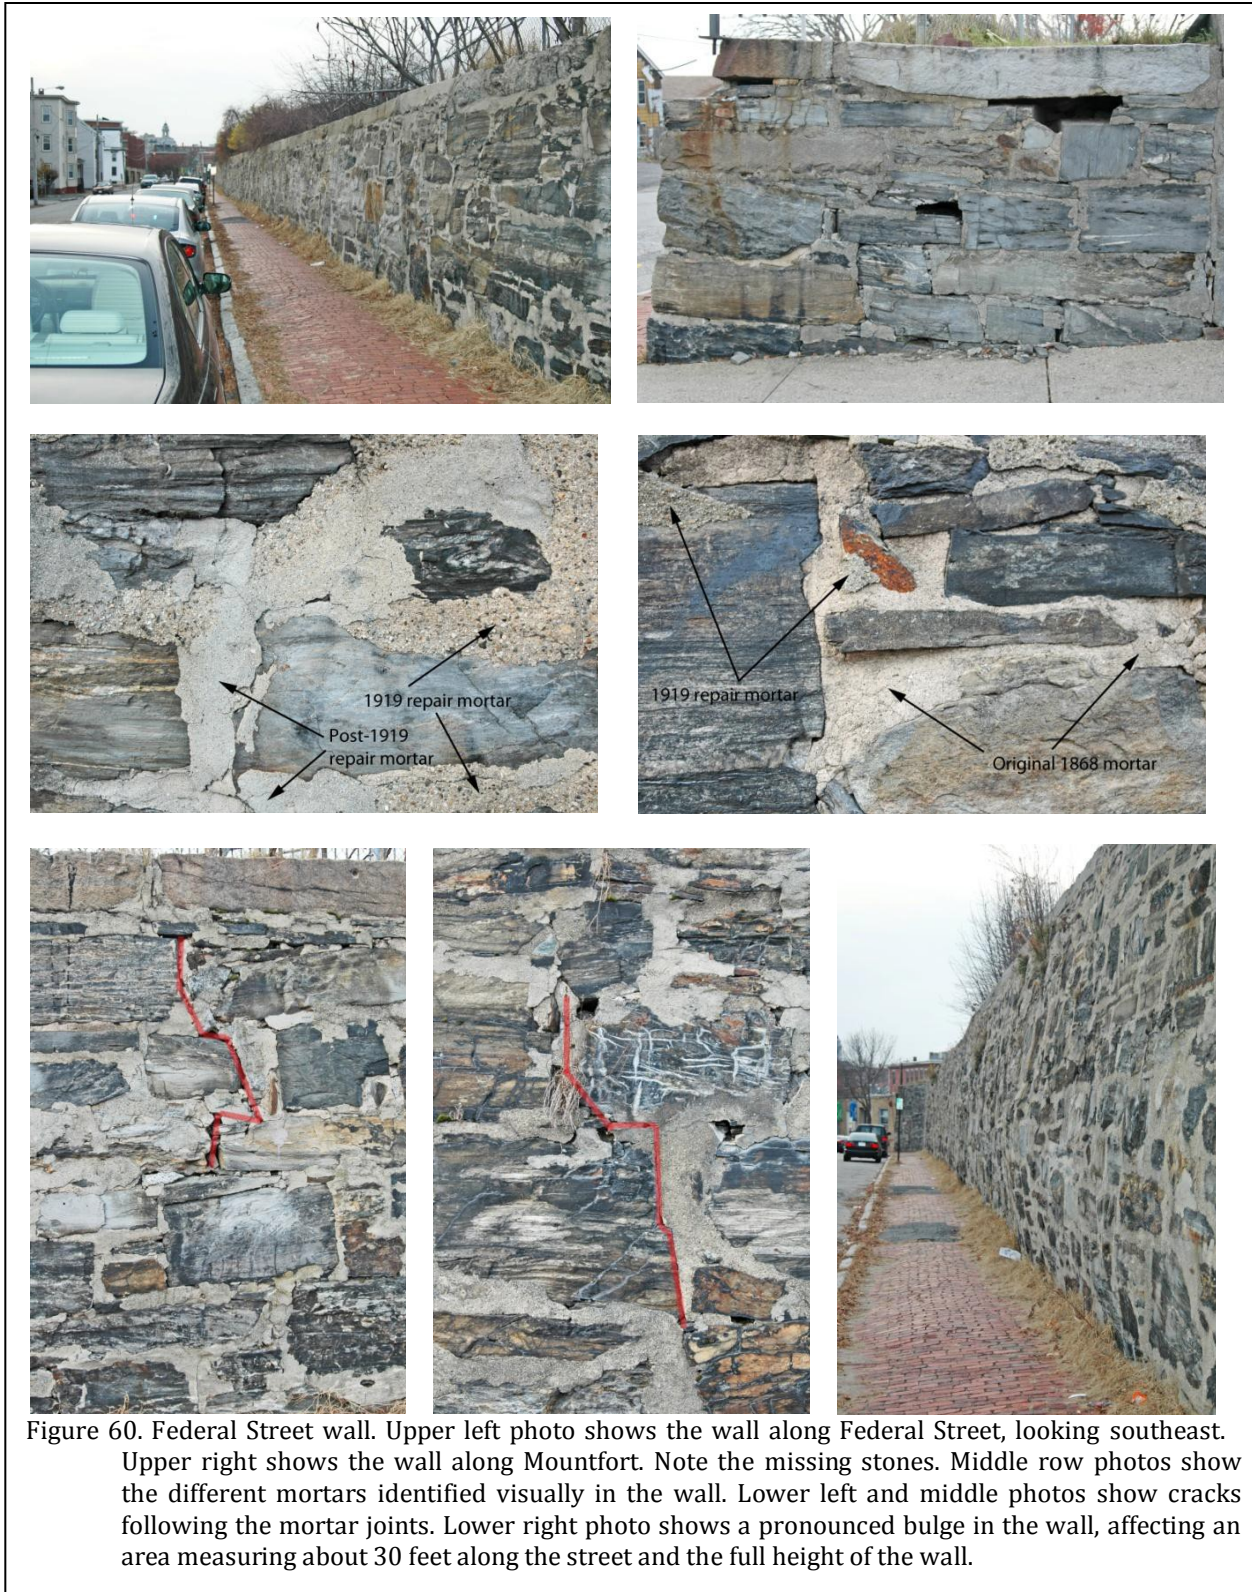
stone. The original mortar appears to be identifiable, as are two repair episodes. The first, thought to date to 1919, consists of a hard Portland cement mortar with abundant coarse sand and fine gravel. There is a later episode of repair using a similar hard Portland cement mortar with fine to medium sand.

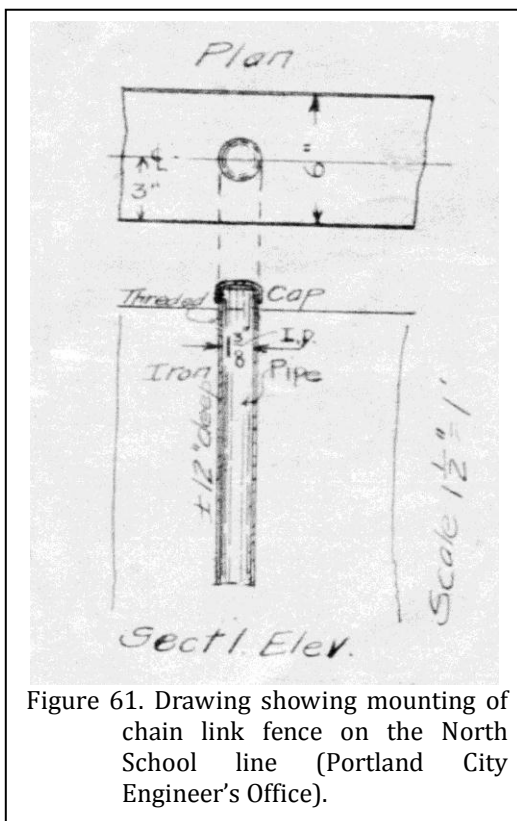
Figure 61. Drawing showing mounting of chain link fence on the North School line (Portland City Engineer's Office).

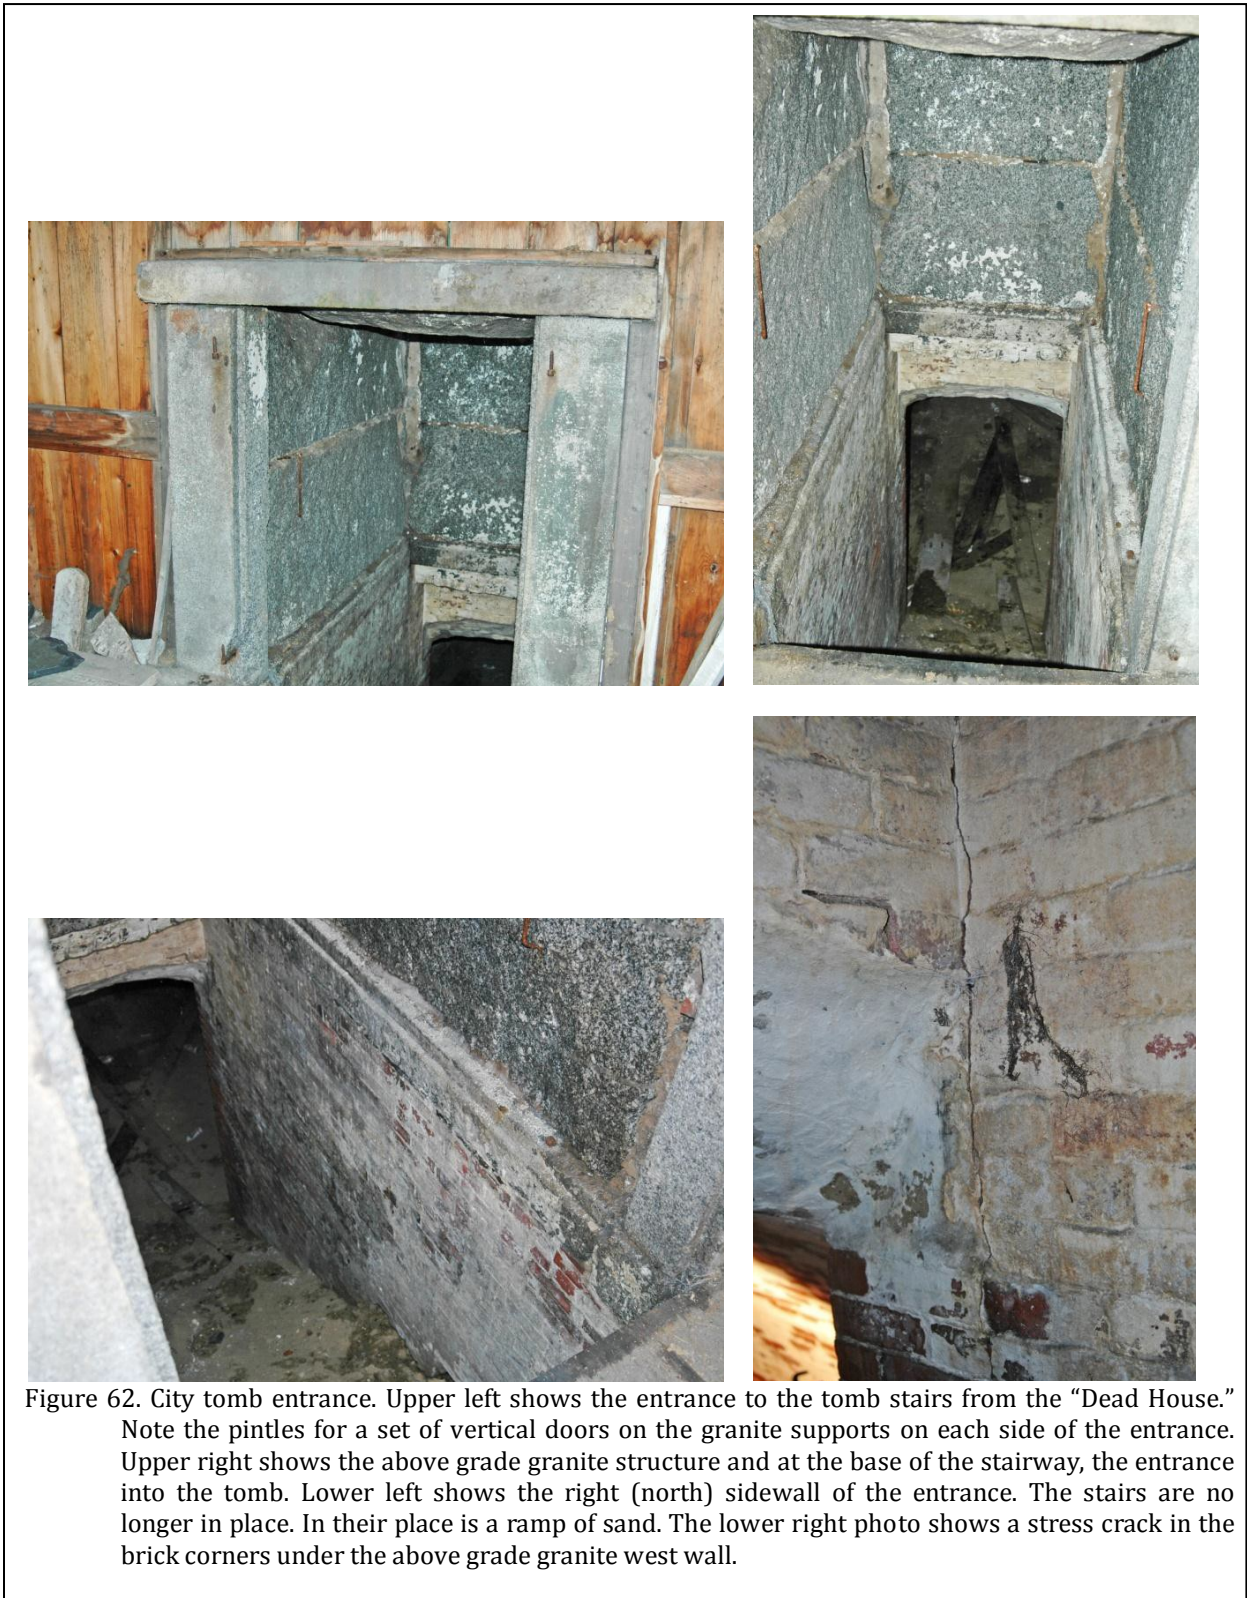
Figure 62. City tomb entrance. Upper left shows the entrance to the tomb stairs from the “Dead House.” Note the pintles for a set of vertical doors on the granite supports on each side of the entrance. Upper right shows the above grade granite structure and at the base of the stairway, the entrance into the tomb. Lower left shows the right (north) sidewall of the entrance. The stairs are no longer in place. In their place is a ramp of sand. The lower right photo shows a stress crack in the brick corners under the above grade granite west wall.

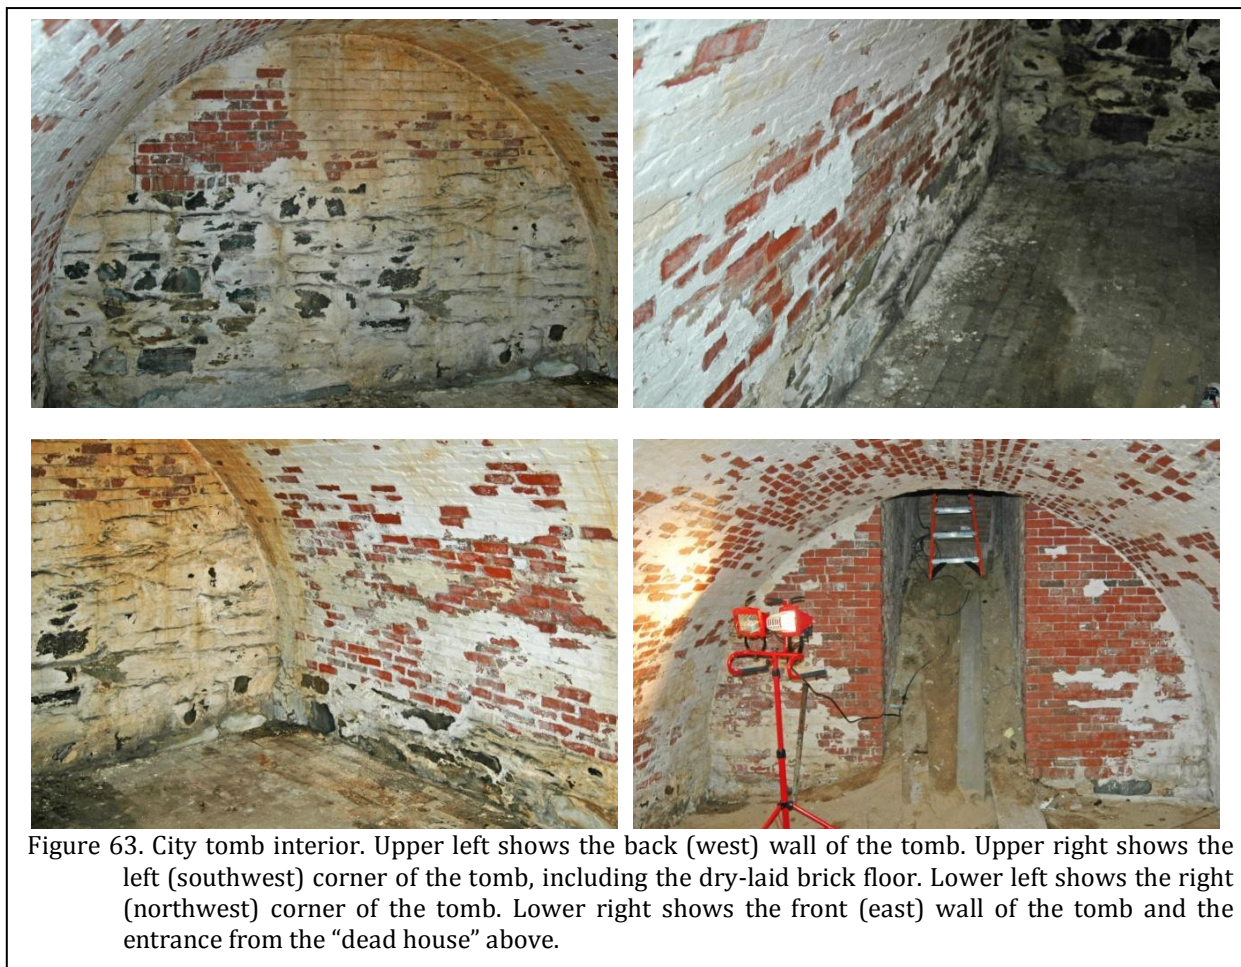
Figure 63. City tomb interior. Upper left shows the back (west) wall of the tomb. Upper right shows the left (southwest) corner of the tomb, including the dry-laid brick floor. Lower left shows the right (northwest) corner of the tomb. Lower right shows the front (east) wall of the tomb and the entrance from the “dead house” above.

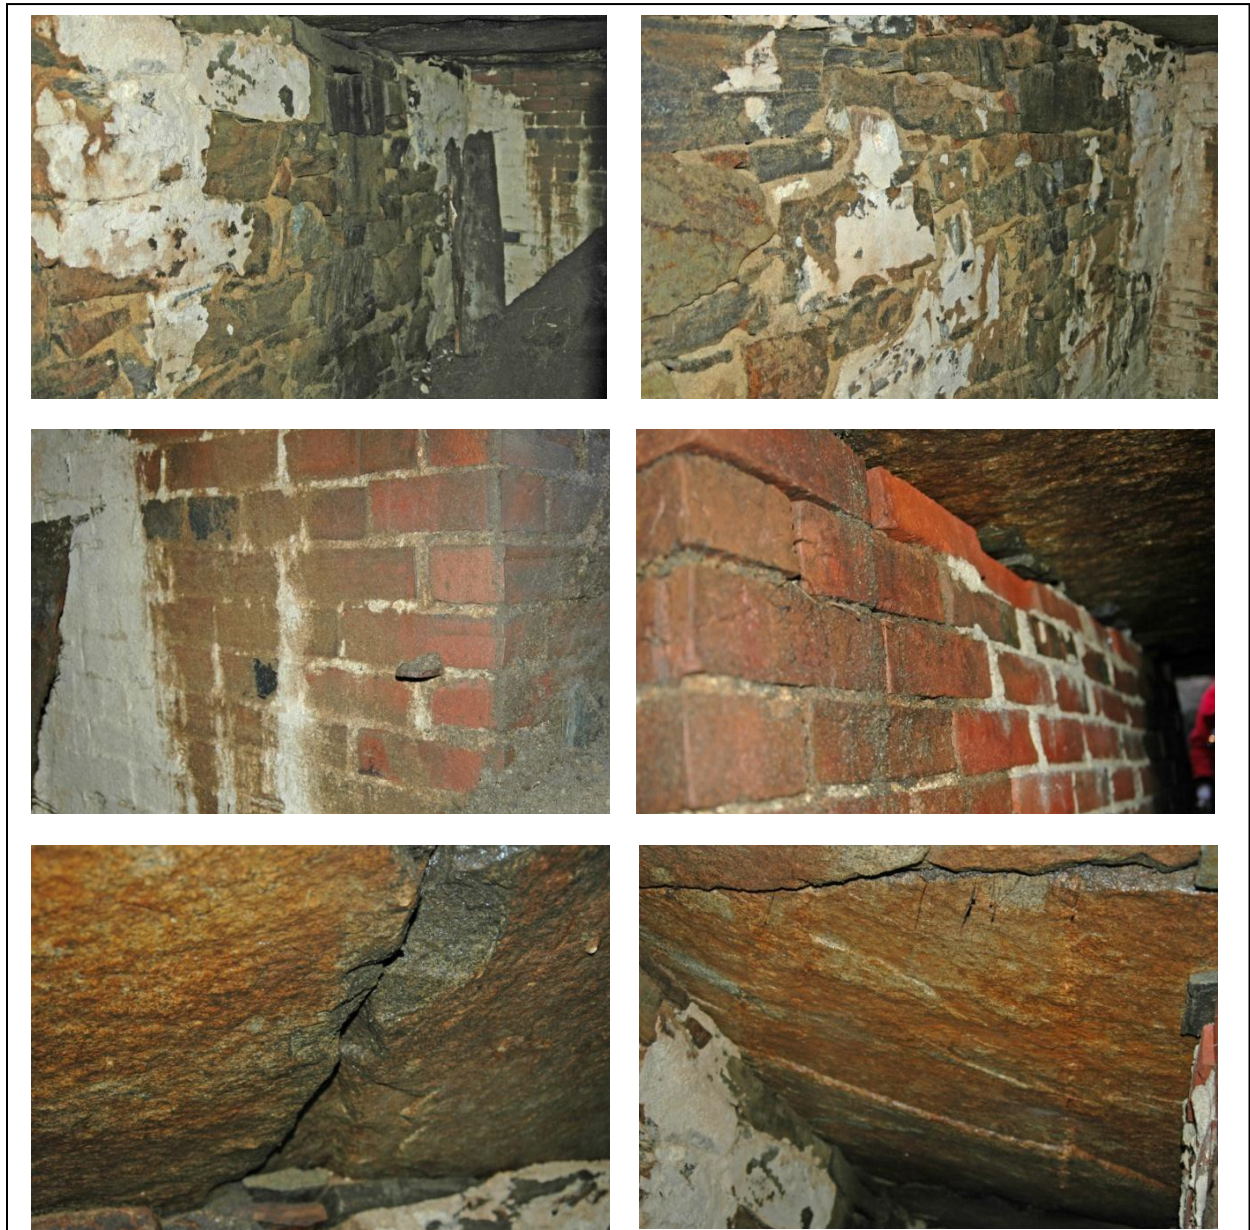
Figure 64. Dyer Tomb (A-22). Upper left photo is of the right (north) side wall looking toward the tomb opening (east). In the corner is part of the old plank covering. In the lower right of the photo is the soil spilling in from the tomb entrance. Upper right photo shows the left (south) side wall looking toward the back of the tomb (west). Middle left photo shows the brick wall north of the opening. Note the iron eye bolt. Middle right photo shows the added central wall, looking toward the tomb opening. Note repointed brick. This wall, unlike the tomb walls, has never been whitewashed. Lower left photo shows the wet ceiling of the tomb to the left (south) of the central wall (in the background). Lower right photo shows a crack in the ceiling.

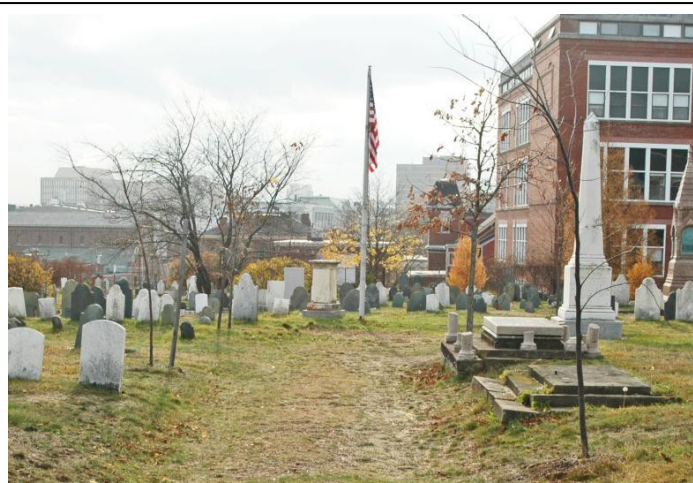
Figure 67. Flag and flagpole in Eastern Cemetery. There does not appear to be a constituency maintaining this feature and it should be removed from the cemetery.

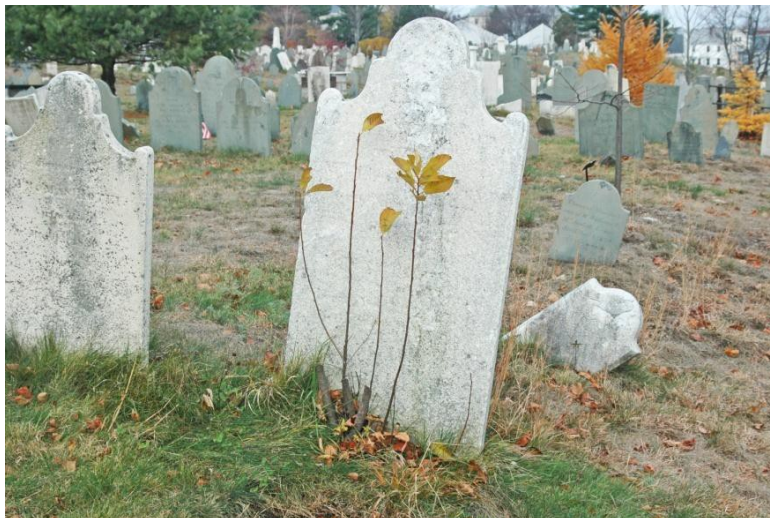
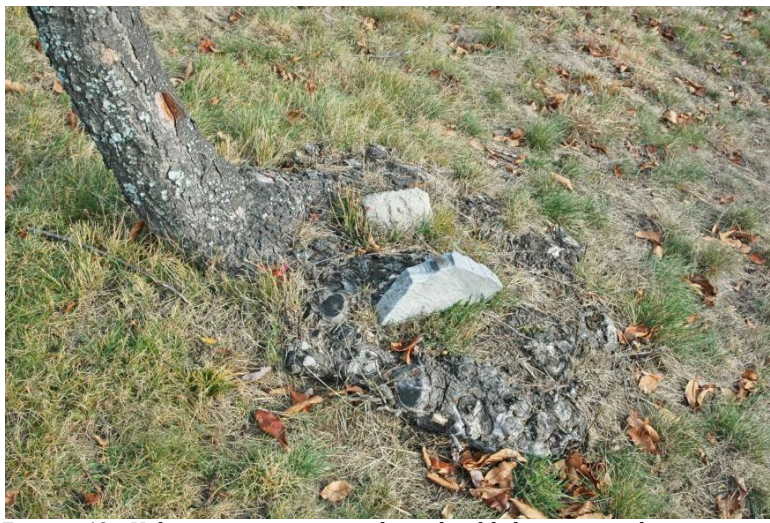
Figure 69. Voluntary vegetation that should be removed to prevent damage to the adjacent monuments. The upper photo shows suckering vegetation that should have been cut flush to the ground and then have had Roundup painted on the stump.

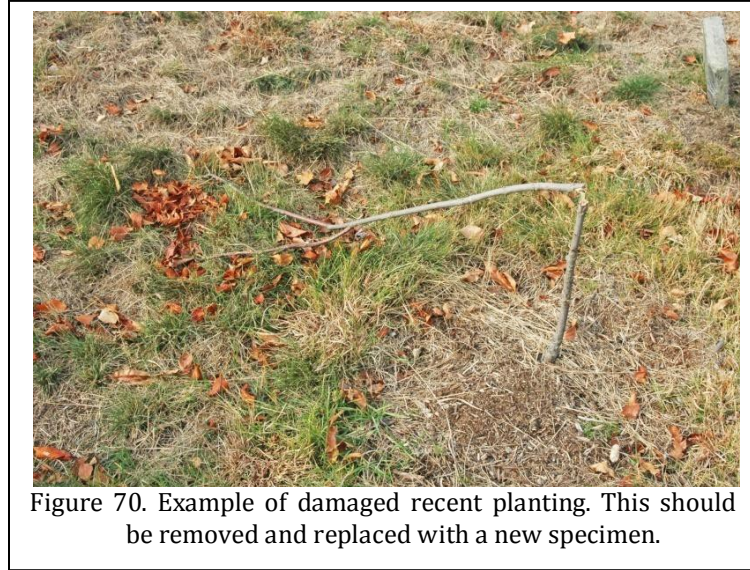
Figure 70. Example of damaged recent planting. This should be removed and replaced with a new specimen.

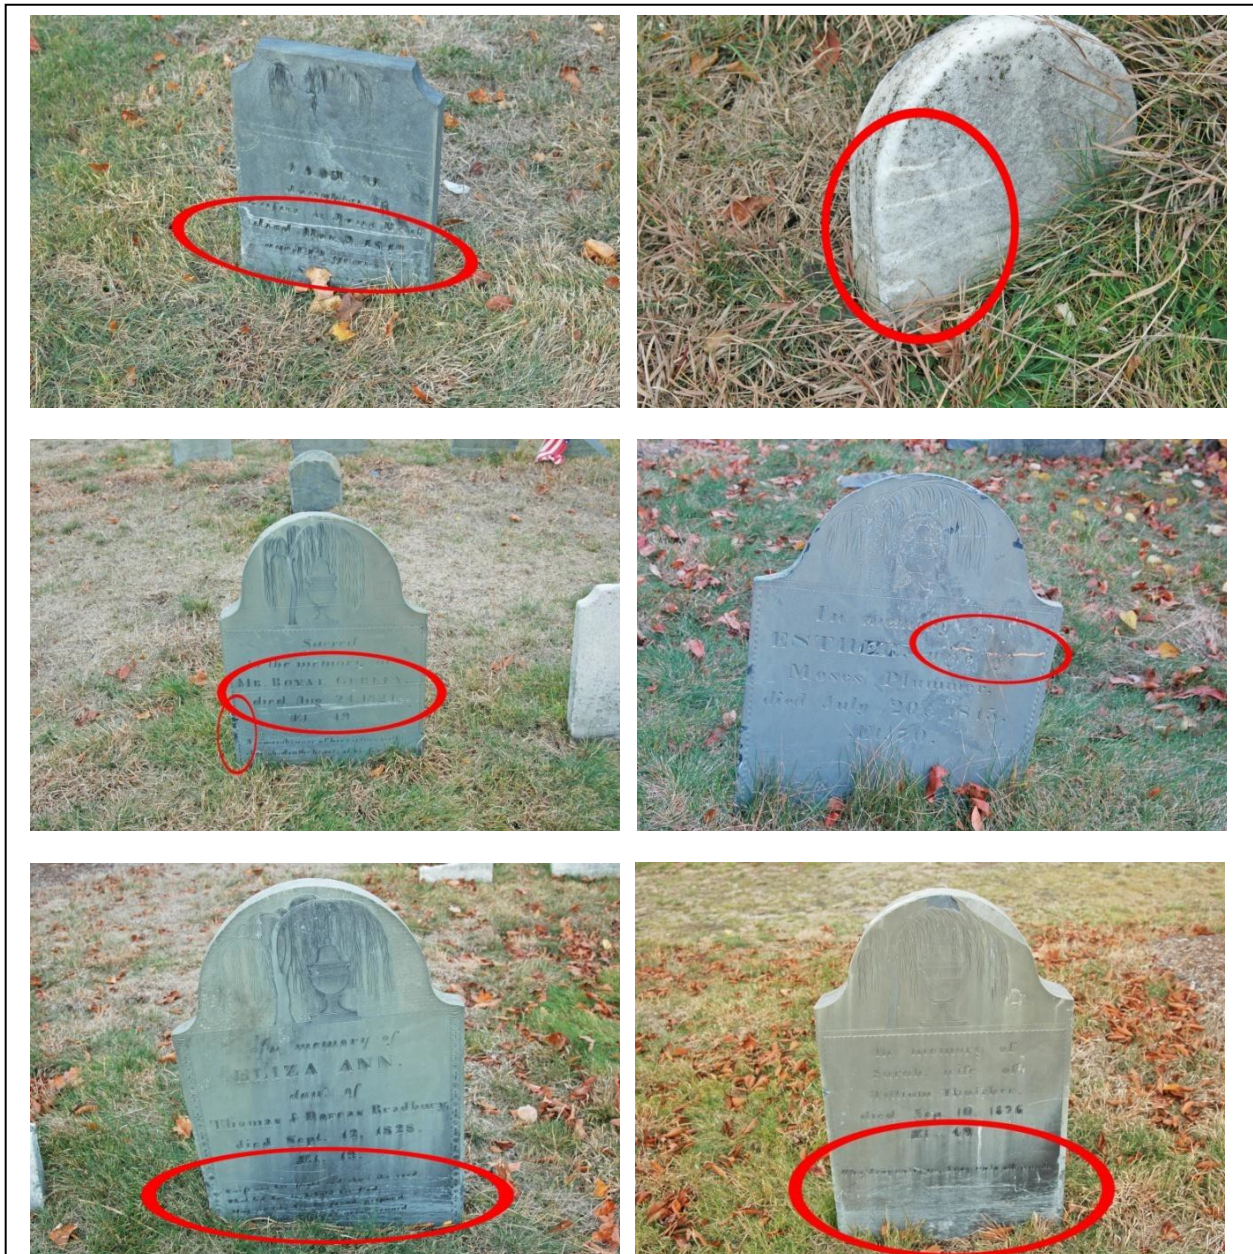
Figure 71. Examples of mower and trimmer damage to stones in Eastern Cemetery. Upper and middle photos show typical scrapes and damage caused by mowers. The photo on the middle right reveals paint transfer from the mower onto the stone itself. The photos in the bottom row show parallel striations on the stones caused by careless trimmer use with a line too heavy for cemetery work.

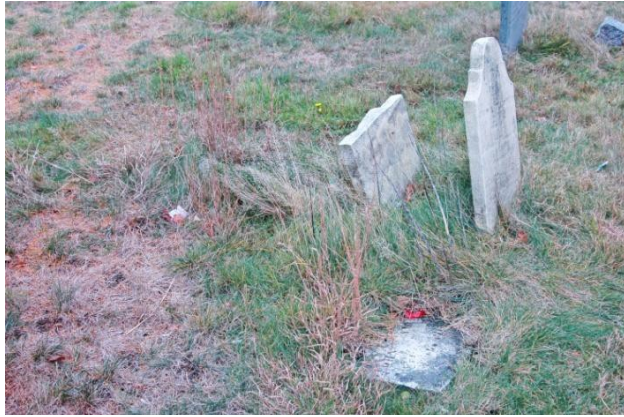
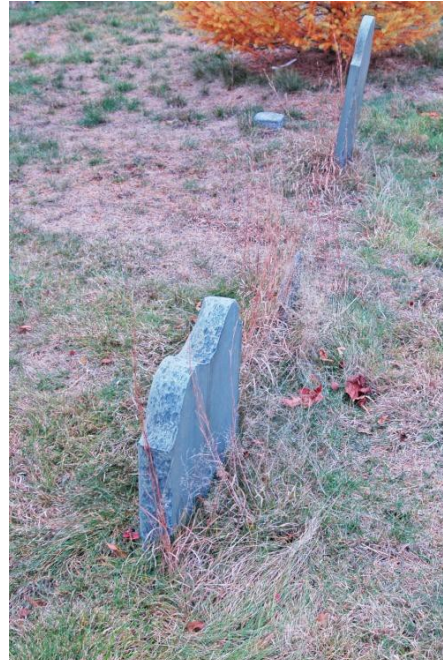
Figure 72. Height of the grass prior to the most recent mowing. In missed areas it is clear that the grass was allowed to grow to 10-14" before being mowed. This would completely hide some monuments and contribute to the damage observed in the cemetery.

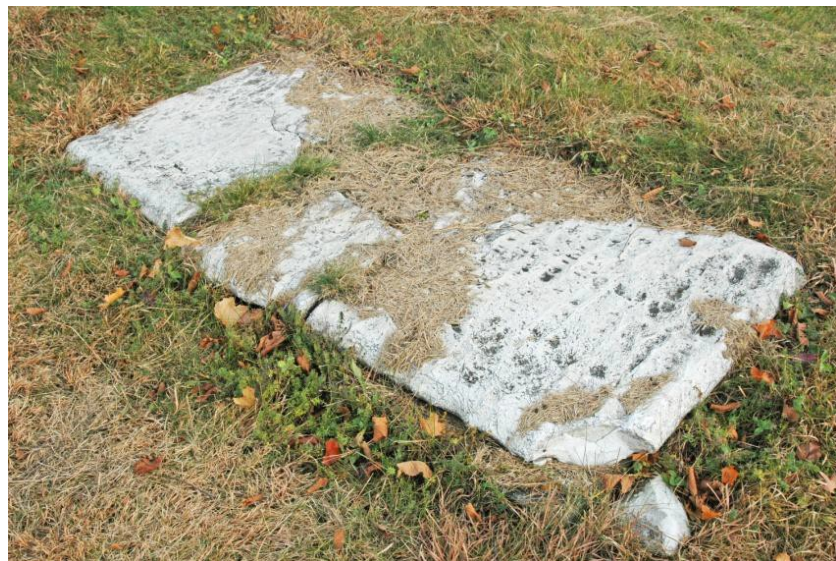
Figure 73. Grass debris must not be allowed to remain on stones.
