MASTER PLAN FOR EASTERN CEMETERY, CITY OF PORTLAND, MAINE

**MASTER PLAN FOR
EASTERN CEMETERY
CITY OF PORTLAND, MAINE**

Prepared By: Michael
Trinkley, Ph.D. and
Debi Hacker

March 1, 2011

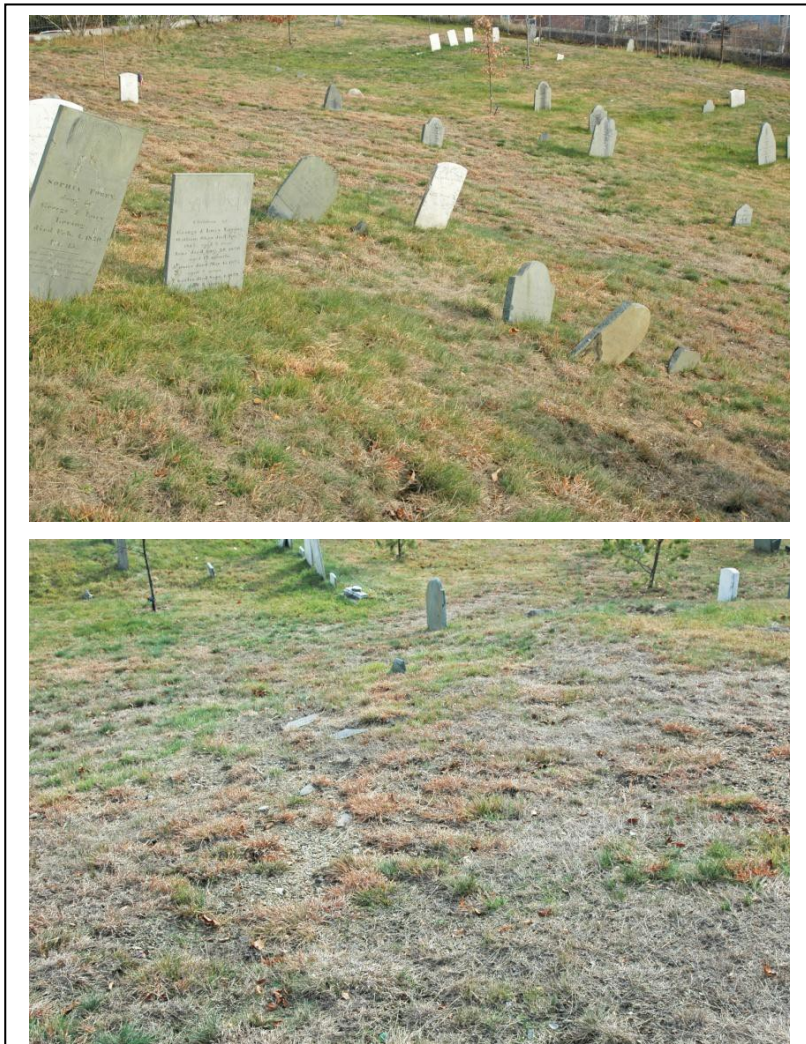
Figure 78. Erosion at the eastern slope in the cemetery. The upper photograph shows how this erosion has caused stones in this area to lean – these should be reset. The lower photograph illustrates compaction on this slope that is causing rainwater to run off, rather than be absorbed.

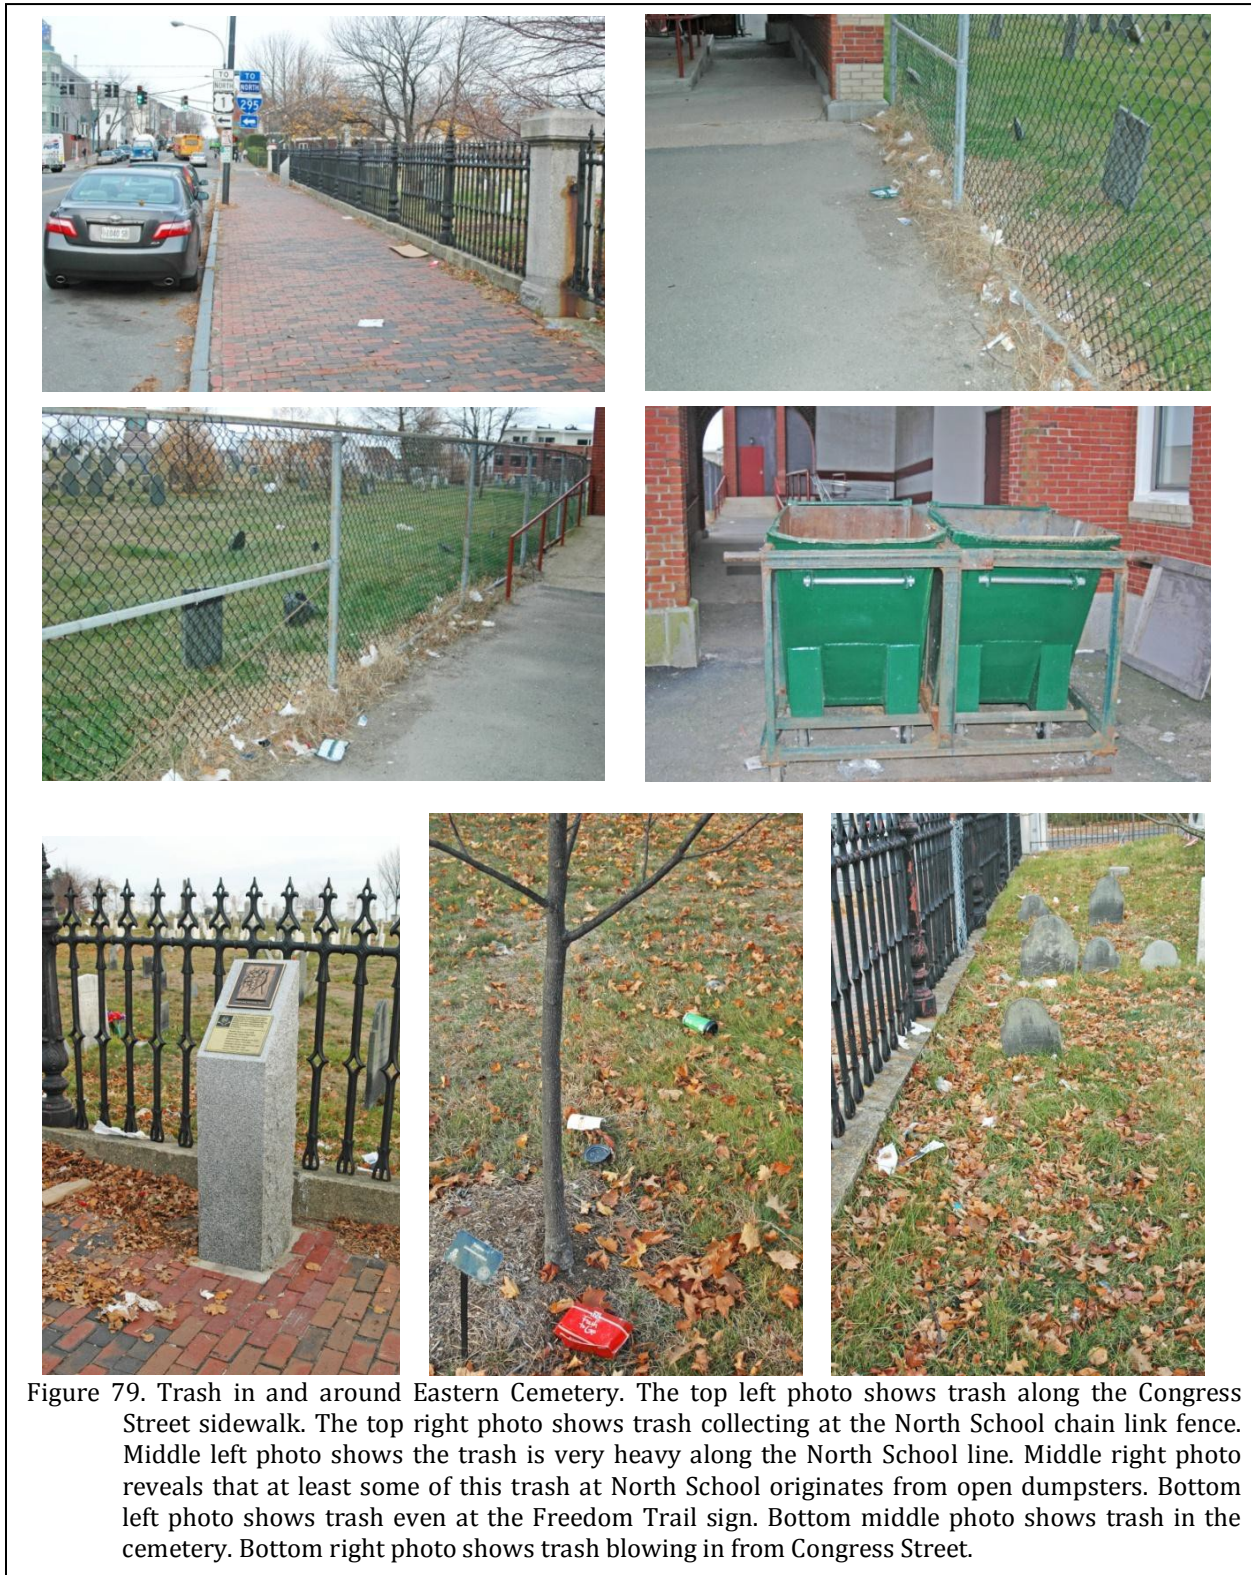
Figure 79. Trash in and around Eastern Cemetery. The top left photo shows trash along the Congress Street sidewalk. The top right photo shows trash collecting at the North School chain link fence. Middle left photo shows the trash is very heavy along the North School line. Middle right photo reveals that at least some of this trash at North School originates from open dumpsters. Bottom left photo shows trash even at the Freedom Trail sign. Bottom middle photo shows trash in the cemetery. Bottom right photo shows trash blowing in from Congress Street.

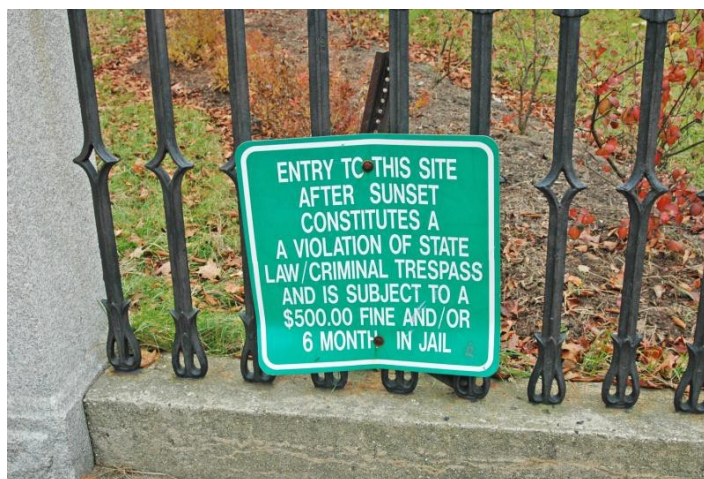
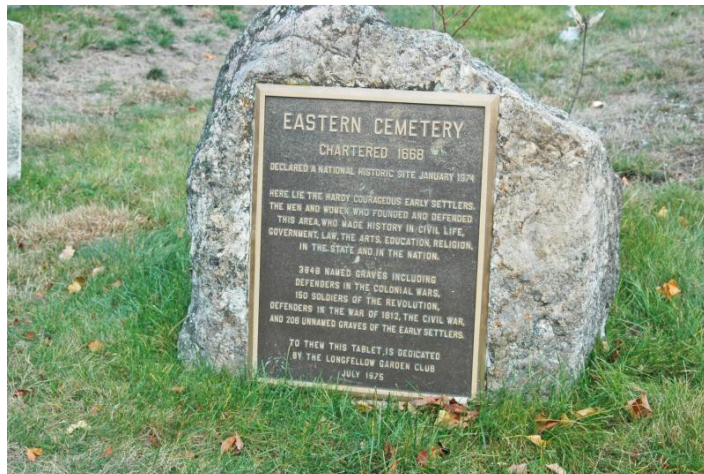
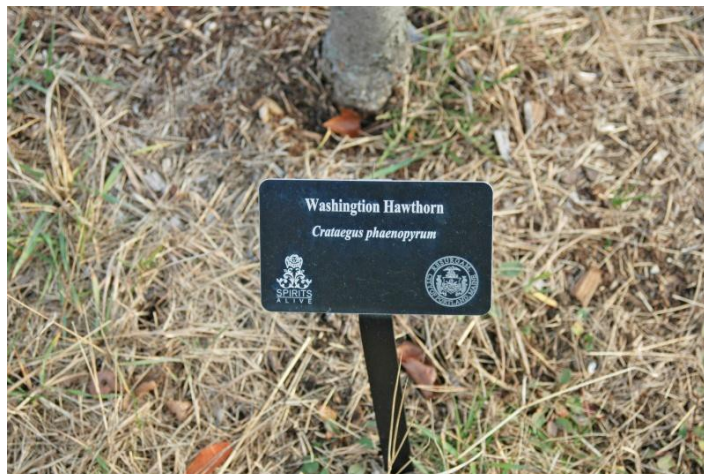
Figure 80. Signage at Eastern Cemetery is inadequate. The top photo shows the only regulatory signage currently present at the cemetery. The bottom photo shows one of the plant tags still present.

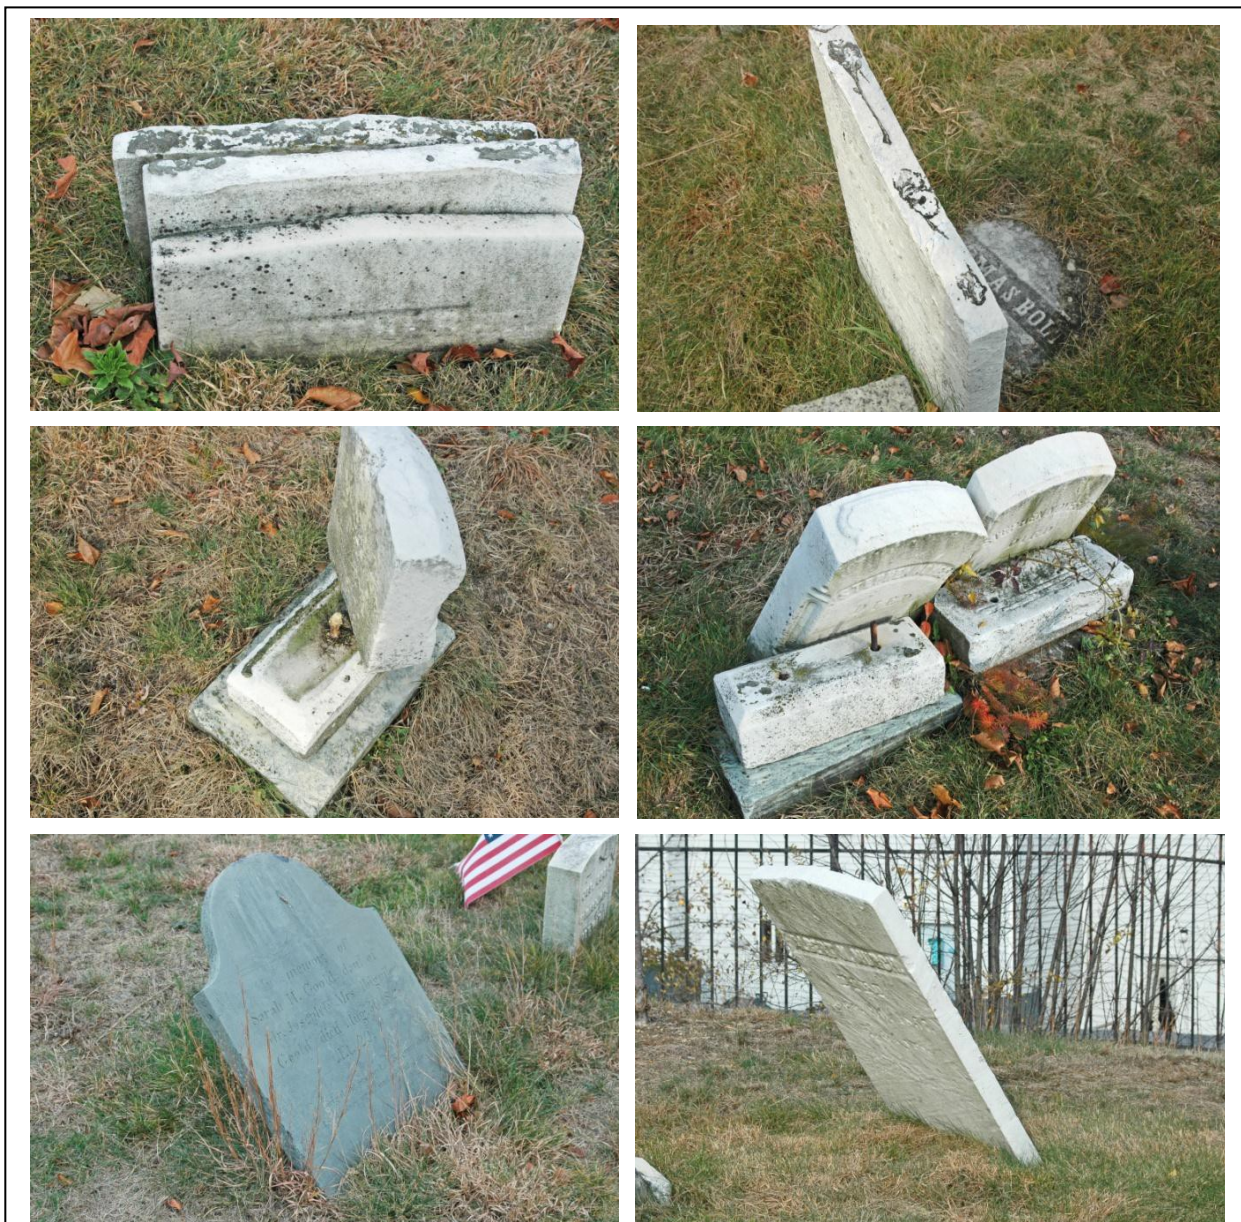
Figure 81. Conservation issues. Top row shows stones that have old “simple epoxy” repairs that have failed. On the left the stone fragments have been reset one behind another. On the right the top of the stone is still in the ground and subject to additional damage. These stones should be drilled and pinned, returning them to their original condition and promoting the three-dimensional appearance of the cemetery. The middle row show die on base stones with ferrous pins. The example on the left shows that the pin was set with brimstone, the old name for melted sulfur. Unfortunately sulfur promotes iron corrosion, exacerbating the likelihood of iron jacking. These should be removed and replaced with fiberglass pins. The bottom row of photographs shows stones with tilts in excess of 20°. Stones with such severe tilts pose a threat to themselves and should be reset as soon as possible.

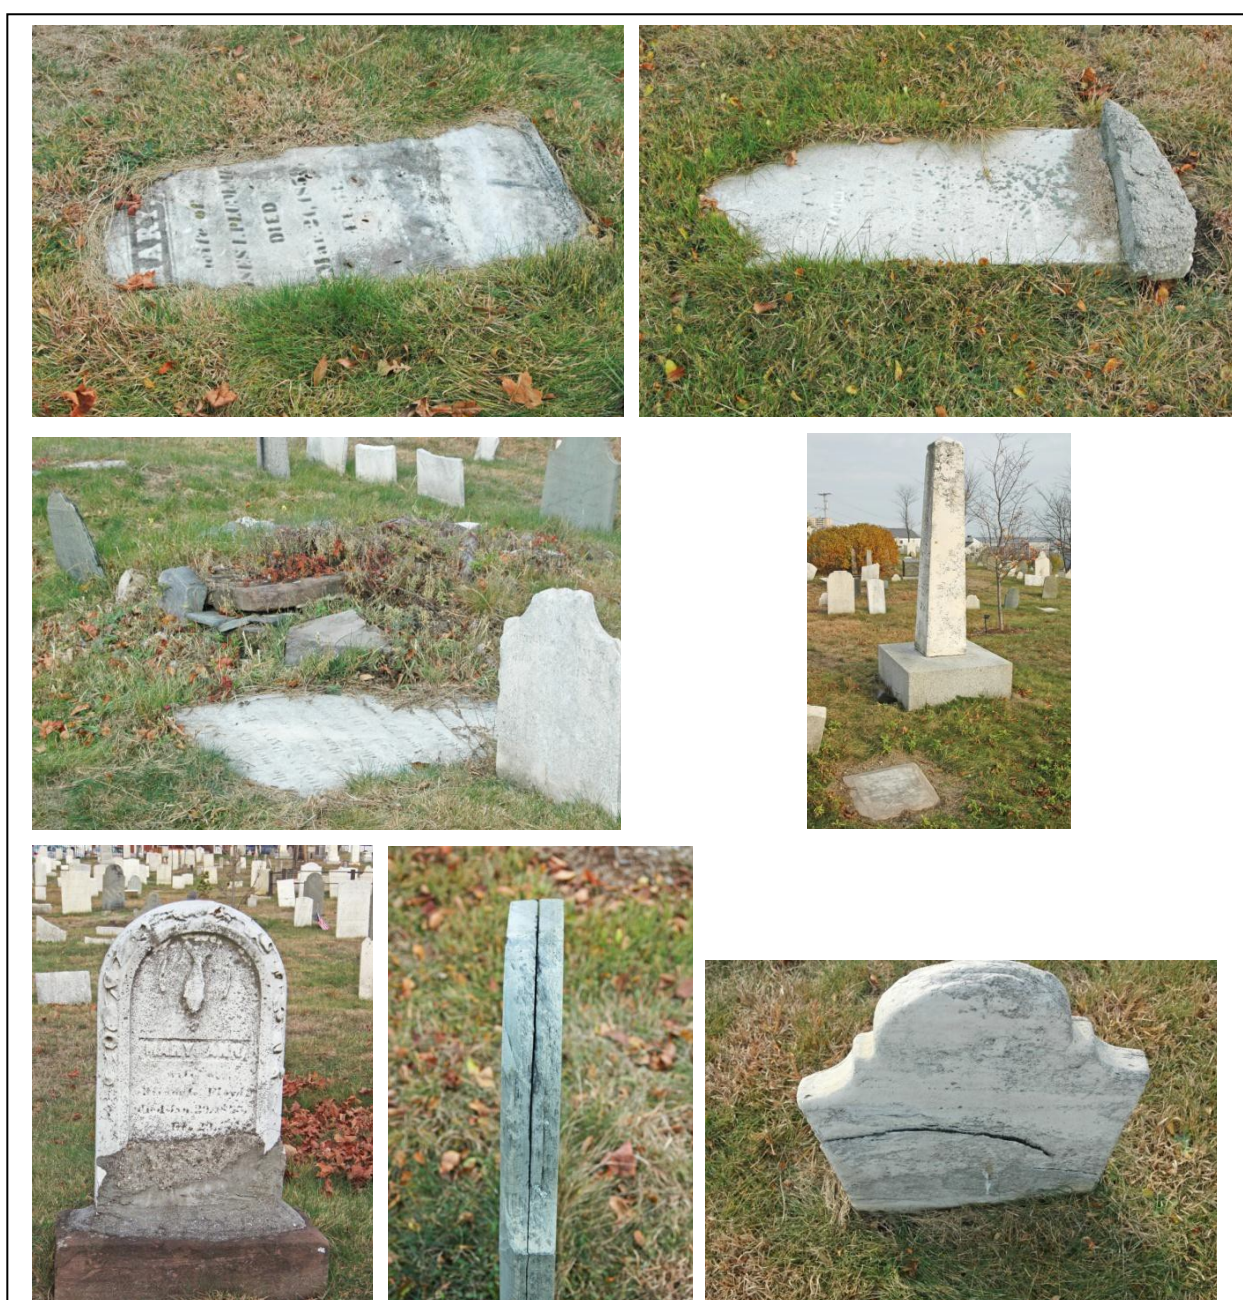
Figure 82. Conservation issues. The top row illustrates two fallen stones that should be reset to prevent additional damage. The photo on the right shows a stone that had previously been reset using a hard Portland cement. Not only did this not keep the stone upright, but it could cause additional damage. A conservator should carefully remove the concrete, allowing the stone to be reset in a pea gravel bed. The middle row, left photo shows a collapsed box tomb. The ledger is intact, but laying on the ground is subject to additional damage. The image on the right shows an obelisk reset without an intervening base (shown in the left foreground). The bottom row left illustrates the inappropriate use of Portland cement to “repair” a stone. Bottom row middle and right photos show spalling slate and marble.

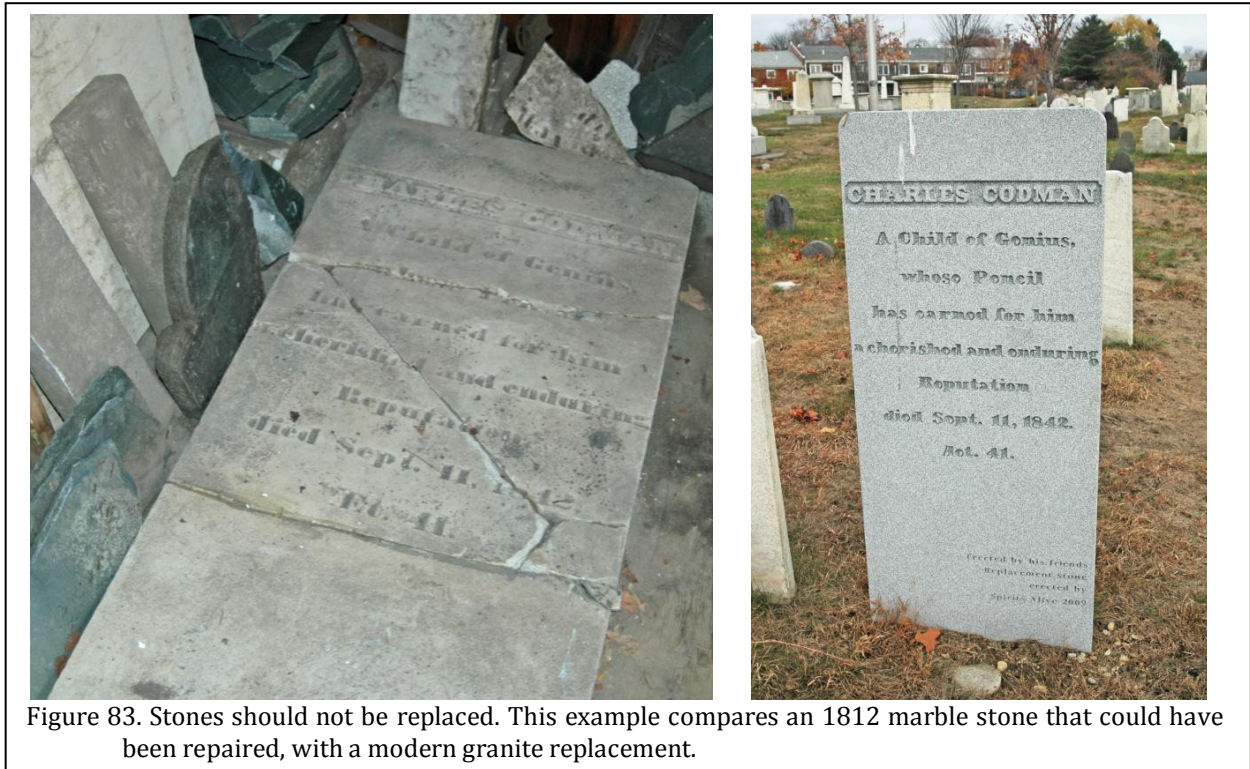
Figure 83. Stones should not be replaced. This example compares an 1812 marble stone that could have been repaired, with a modern granite replacement.

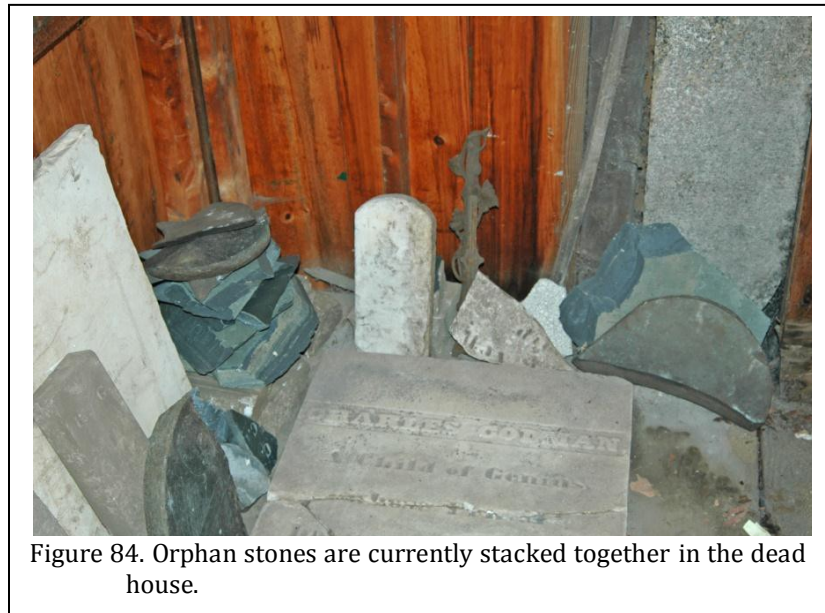
Figure 84. Orphan stones are currently stacked together in the dead house.
